Heritage ¹¹

Introduction: Heritage resources identified in the project survey and inventory process are evaluated to determine their significance. The level of significance is measured by the criteria of the National Register of Historic Places. Projects are usually designed to protect significant sites through avoidance. In rare cases, effects are mitigated through archaeological data recovery methods, including scientific excavation and analysis. In the case of historic structures, mitigation may take the form of detailed architectural documentation.

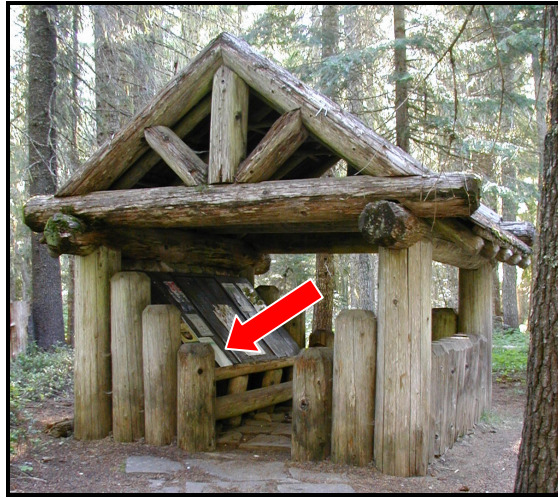
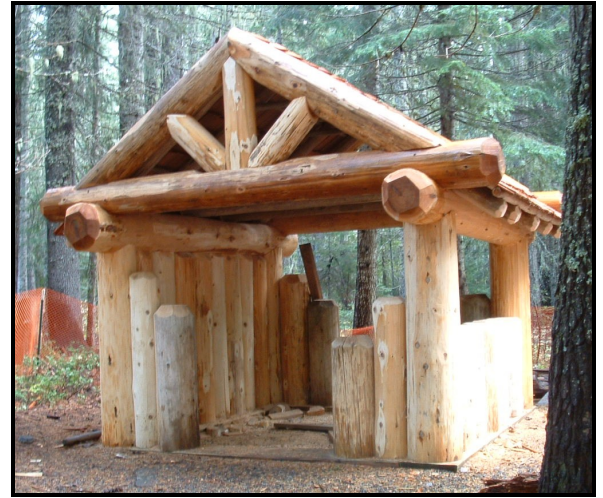
Evaluation: Protective measures were successful in all but one case. Restoration and rehabilitation of the Peterson Information Station followed the standards and guidelines faithfully, with the exception that one upright support in the main façade (see Figure 2) that was inadvertently forgotten in the replacement process.

Figure 2. - The historic Peterson Prairie Information Station, built in 1939 with CCC labor, as it appeared in 2002 (left) and nearing completion of rehabilitation project in 2003 (right). Arrow indicates location of missing post.

Recommended Actions: Complete rehabilitation of the Peterson Prairie Information Station. Remaining work includes reinstallation of the interior signboard and flagstone walkway. The missing post will be replaced at the time other work is done.
